Manhole Inspection Summary

Manhole # S11QQ_006MH

Insp Date: **3/18/09 9:27 AM**

Location Address: **2748 ROSEDLAKE RD** Cross Street: **CARLISLE AVE**

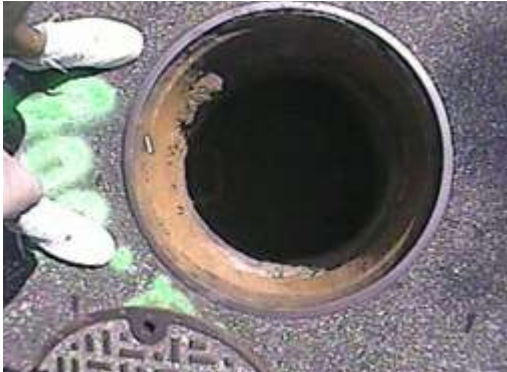
Top View

Frame Offset: **1** (in.) Condition: ☒ Sound ☐ Cracked ☐ Leaks

FRAME OFFSET

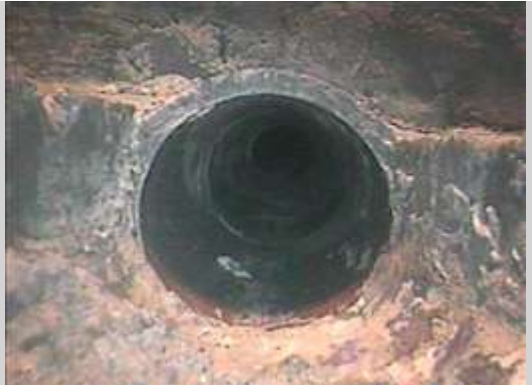
12 O'Clock Outflow

8 in. Circular Gravity Sewer
Pipe Out @ 12 O'Clock

Deposits: ☐ None ☐ Mud ☐ Sludge ☒ **Debris** ☐ Grease

Silt Depth: **8** (in.) Deposits Extent: **Heavy**
